THE BRIGHTON GAS FIRE AND EXPLOSION CATASTROPHE

Town of Brighton (Monroe County), N. Y.

September 21, 1951

THE NATIONAL BOARD OF FIRE UNDERWRITERS

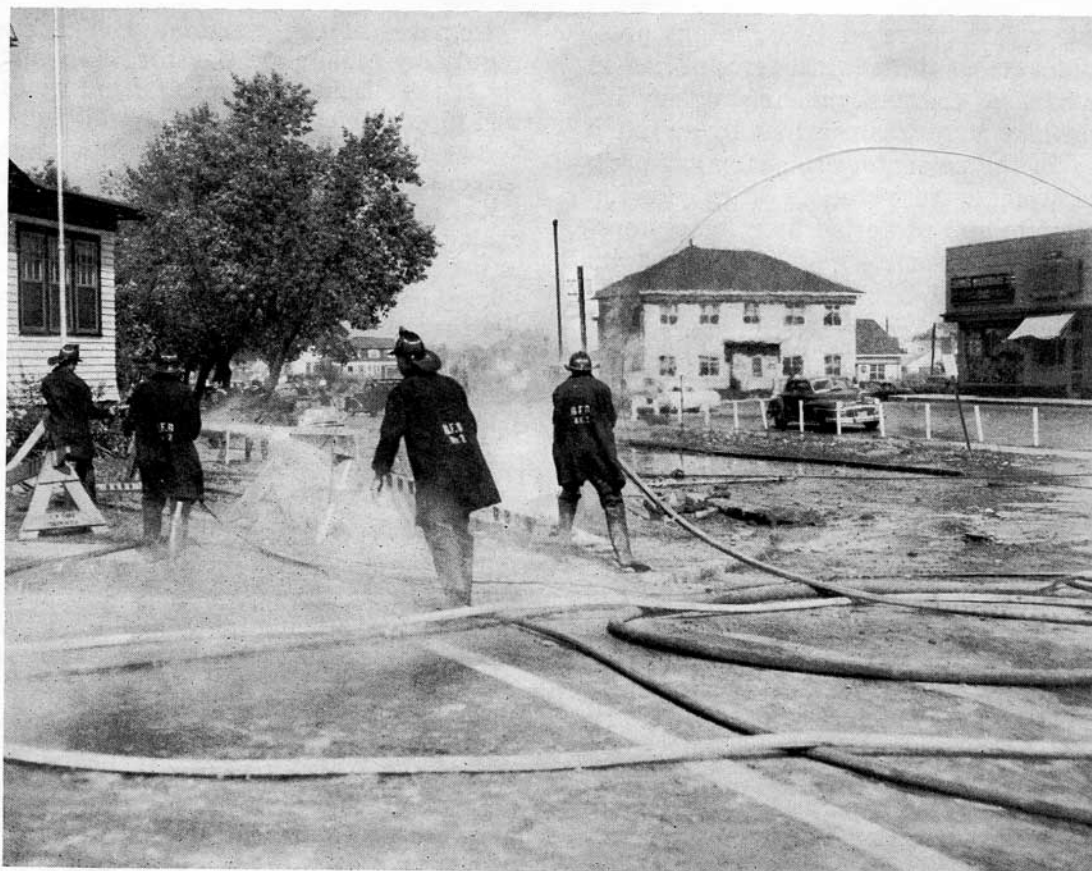
FIG. 4. Brighton firemen controlling fire with water spray around regulator vault after explosion. Note heat wave blur on building toward right of center background.

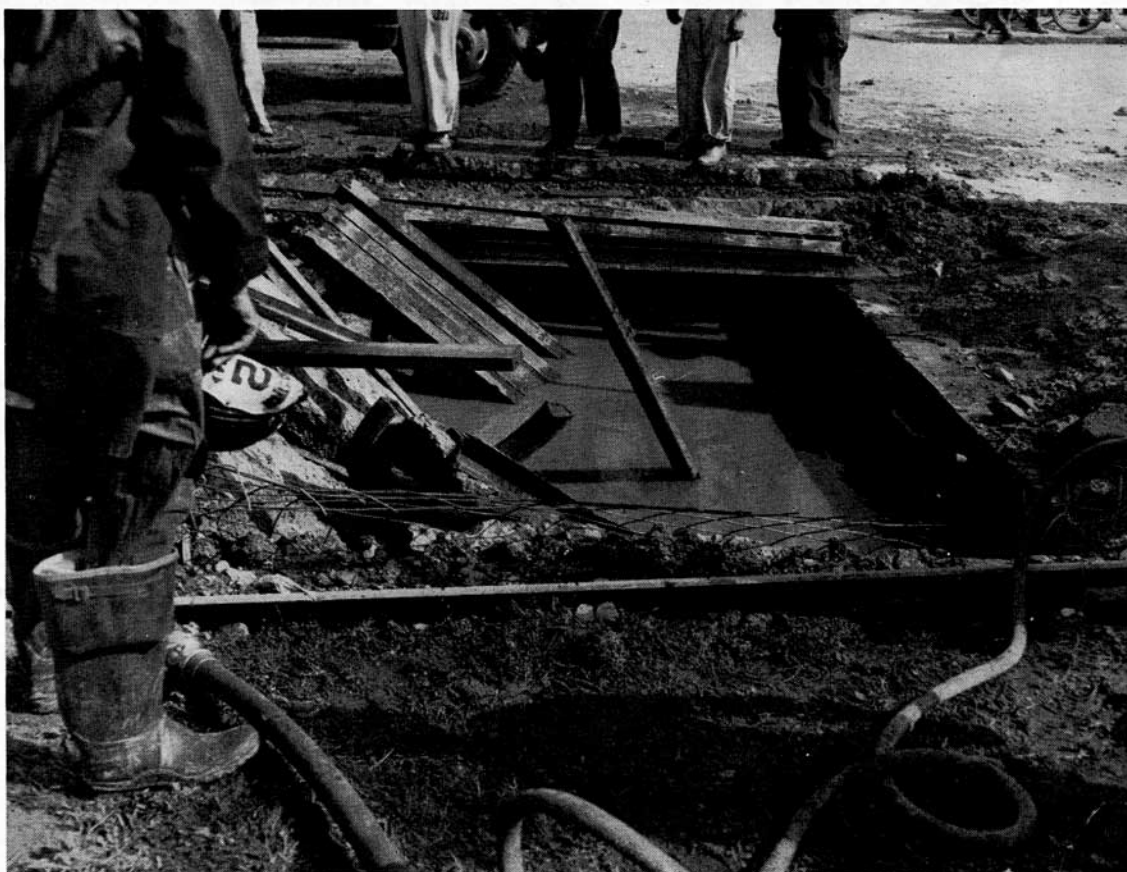
Within a few seconds an explosion rocked the vault. The roof and manhole covers of one section of the vault and portions of the others were blown into the air. The heavy debris of steel reinforcing rails fell back into the vault and ruptured all control pipes, and otherwise fouled or damaged the regulators. Fire ensued immediately at the broken connections.

FIG. 5. View of low-pressure regulator chamber after flooding and extinction of flame, showing steel rail reinforcement of damaged roof. Note wire netting and sidewalk construction forms in foreground.

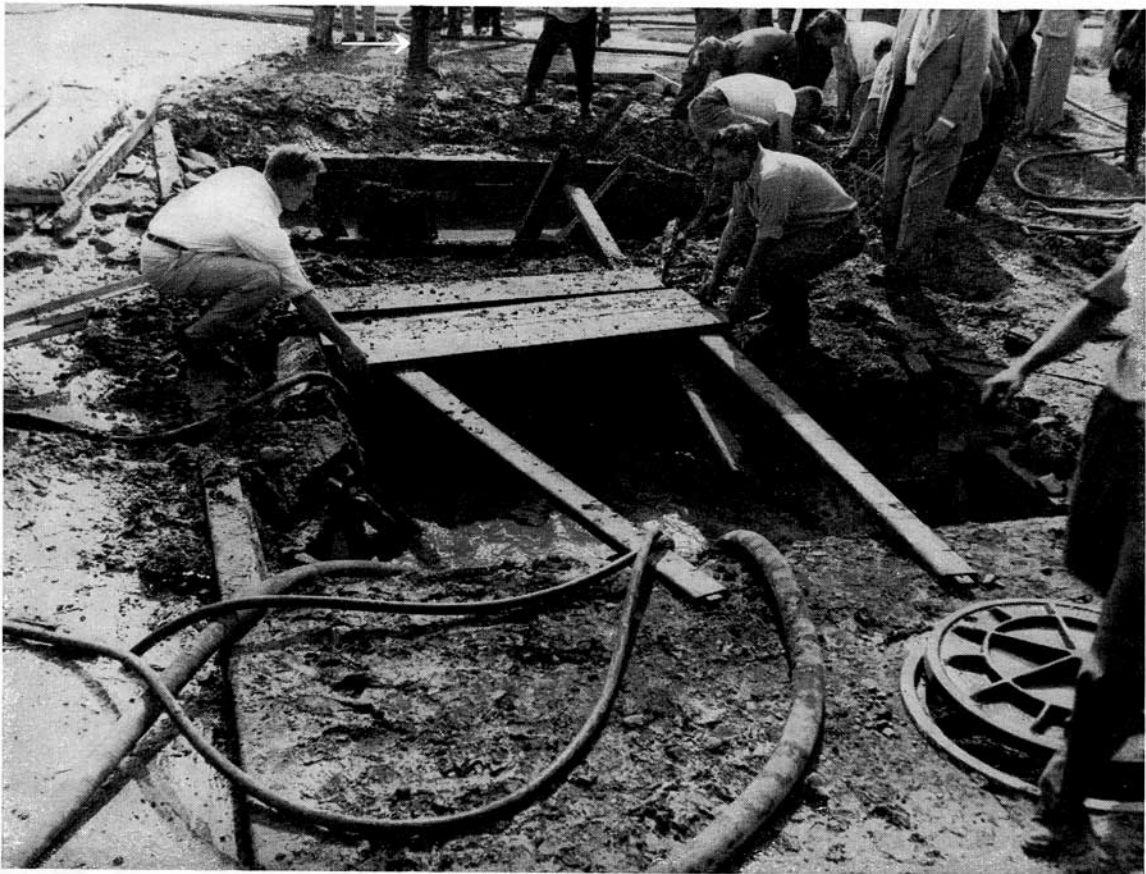
FIG. 6. Use of hose lines to flood gas-main drip connections to control gas flow and permit repair work. Note manhole cover over medium-pressure regulator chamber and gauge box pedestal (vent) left of center background (note arrow), beyond low-pressure chamber.

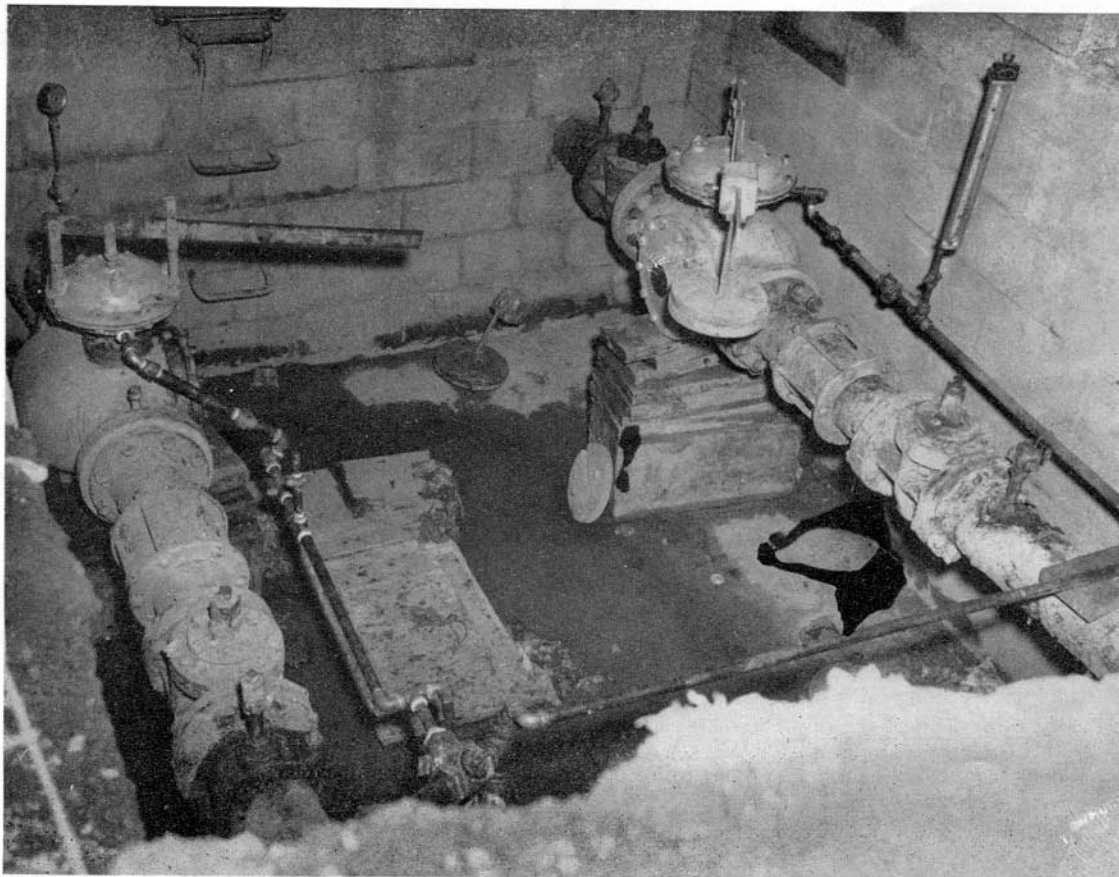
FIG. 9. Interior of medium-pressure regulator chamber; note weighted beams and reconstructed diaphragm pressure control piping.

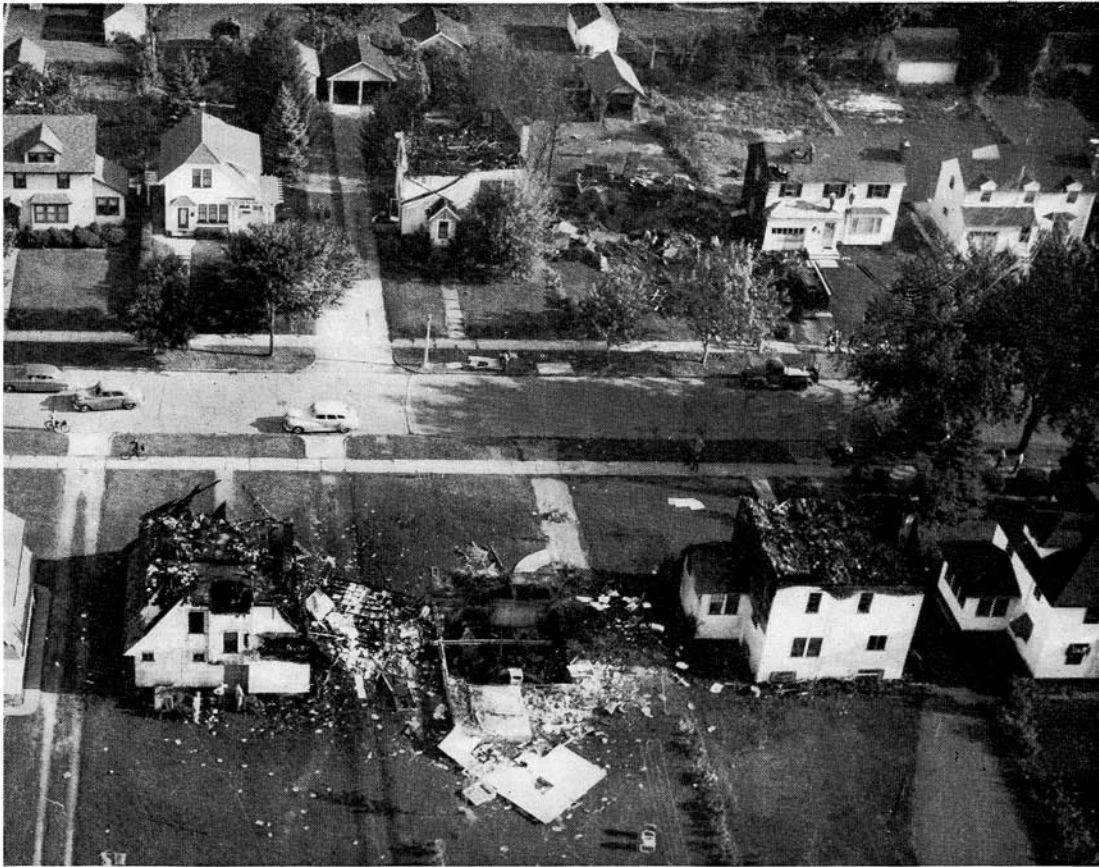
FIG. 11. Antlers Drive—Houses destroyed by explosions and damaged by exposure fires.

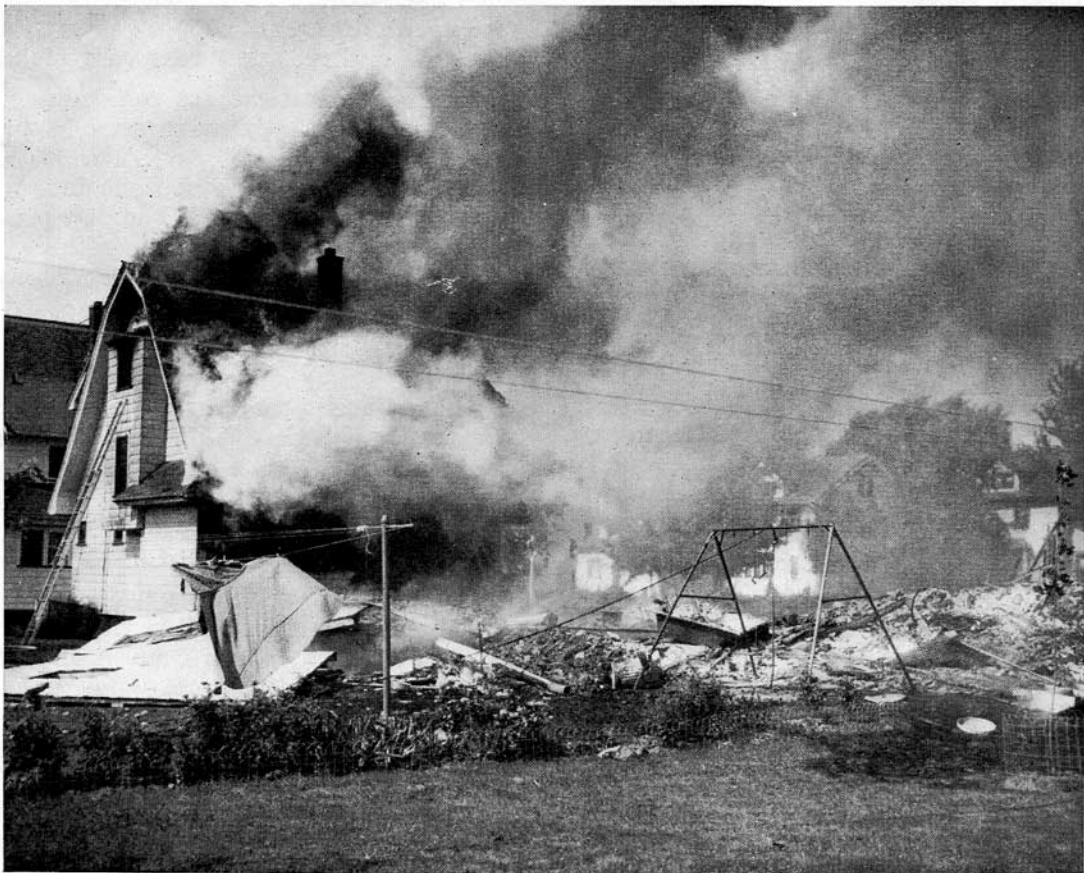
FIG. 12. Exposure fires developed on each side of houses which exploded on Antlers Drive.

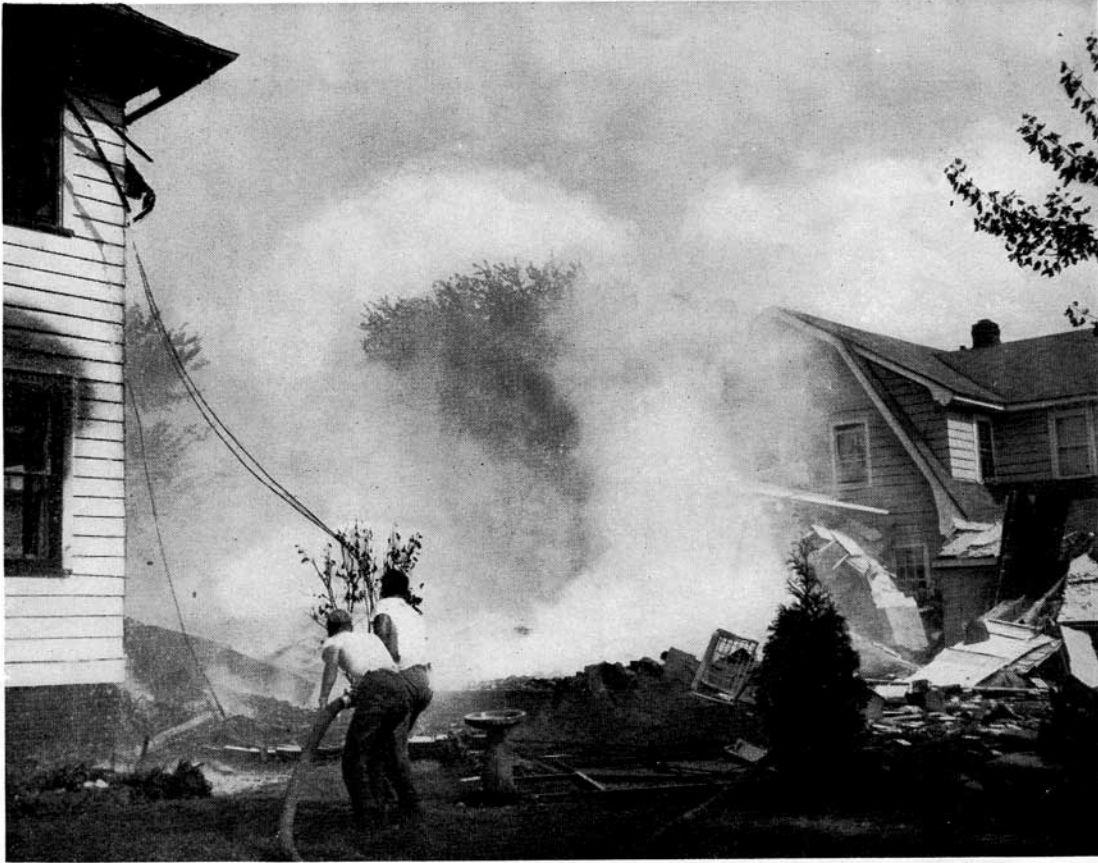
FIG. 13. Typical situations which faced volunteer firemen; fire outbreak in left dwelling brought under control, effort being made to prevent spread of fire from debris of a nearby blasted house.

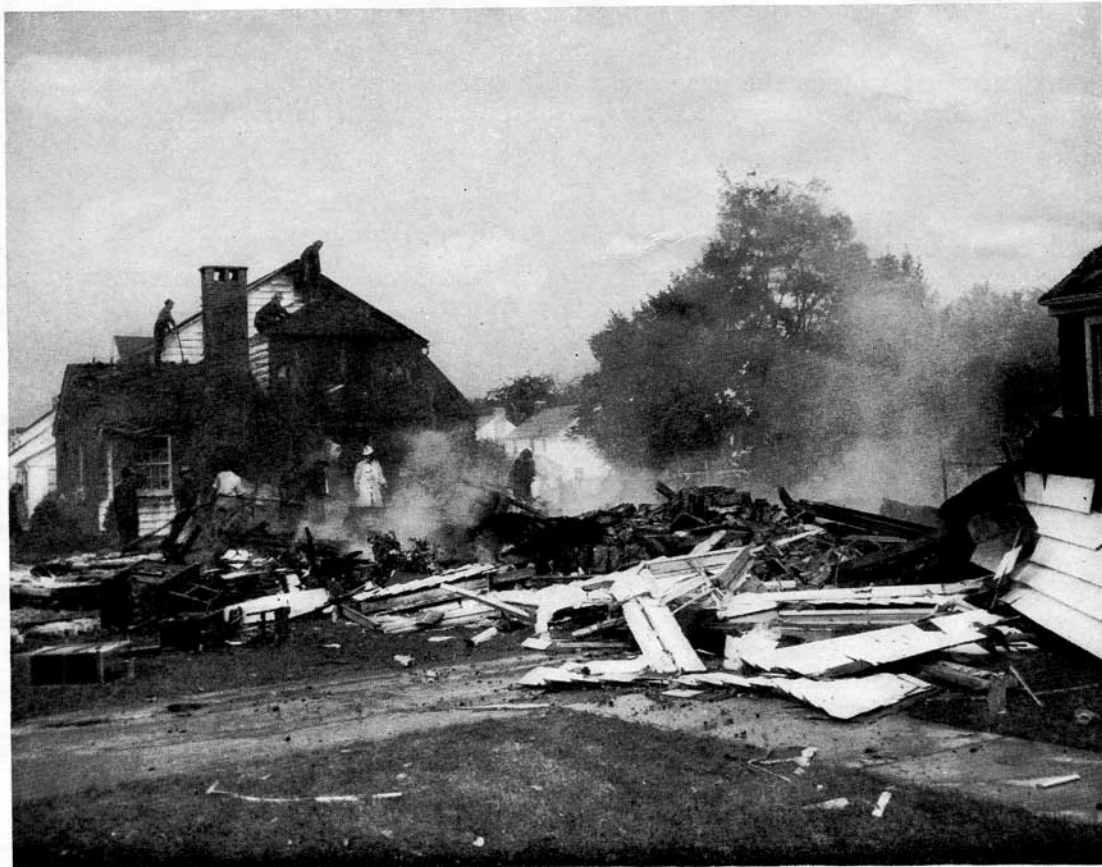
FIG. 14. Blast and fire destruction on Varinna Drive.

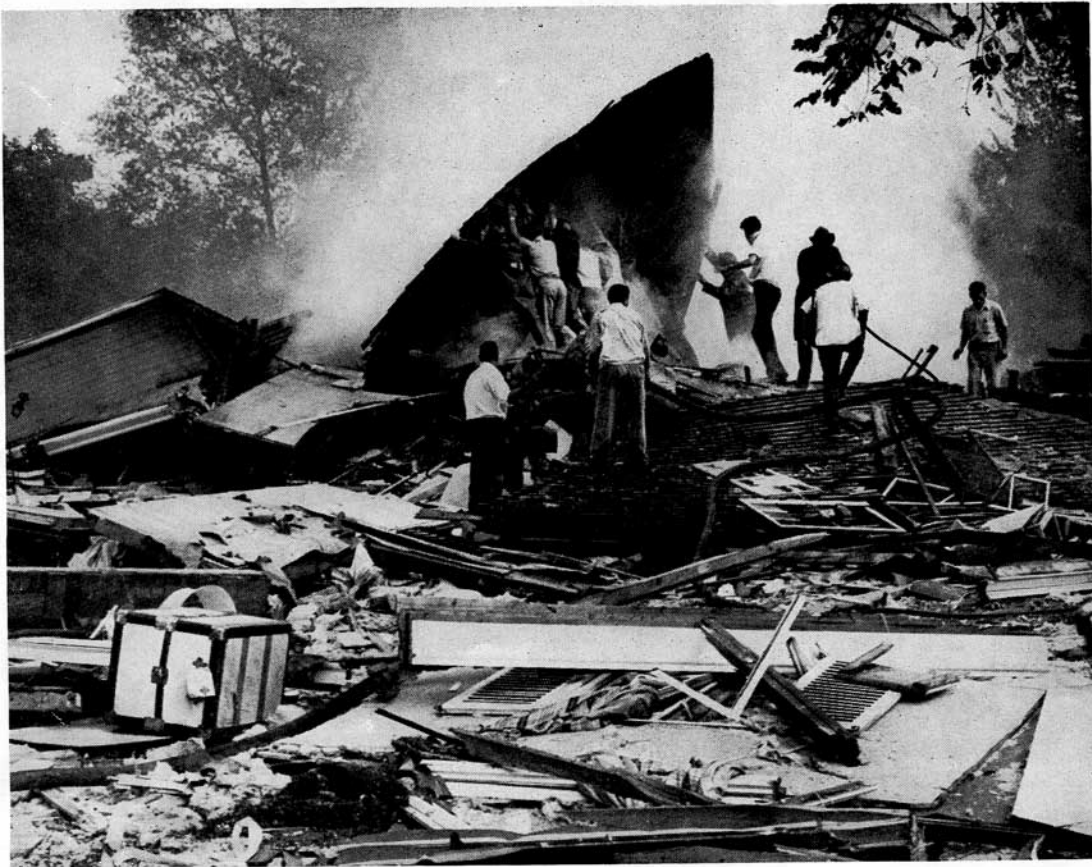
FIG. 15. Complete destruction of houses hindered both the search for possible explosion victims and the fire fighting. (Bonnie Brae Drive)

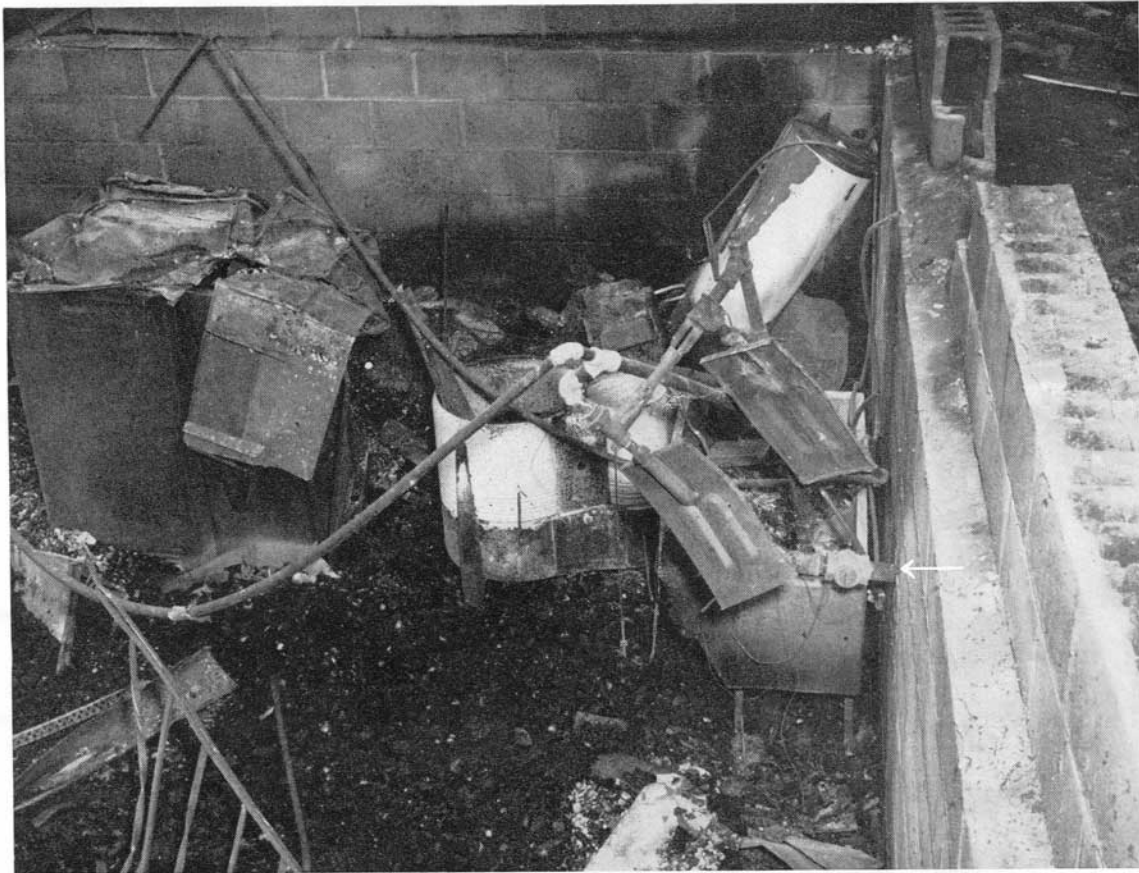
FIG. 16. Remains of foundation of a destroyed home. Note water heater in corner, damaged meter and service shut-off cock on the right (note arrow).

- d. Provision at meters for an easily operable shut-off cock having a permanently affixed indication of method of operation (showing direction of rotation) and a warning of the hazards of turning on gas by anyone except authorized servicemen.

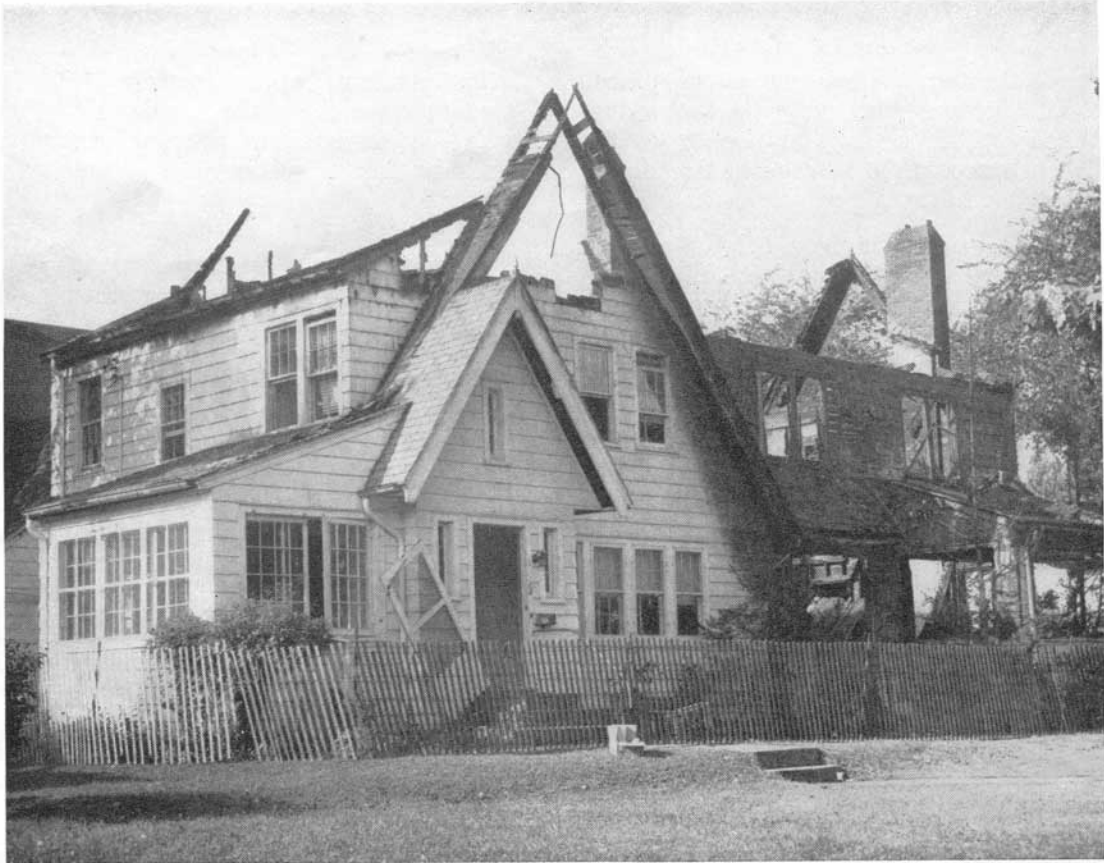
FIG. 17. Damage to this two-family dwelling at the corner of Sylvan Road and Fair Oaks Avenue was limited by a dividing wall extending only to the attic.

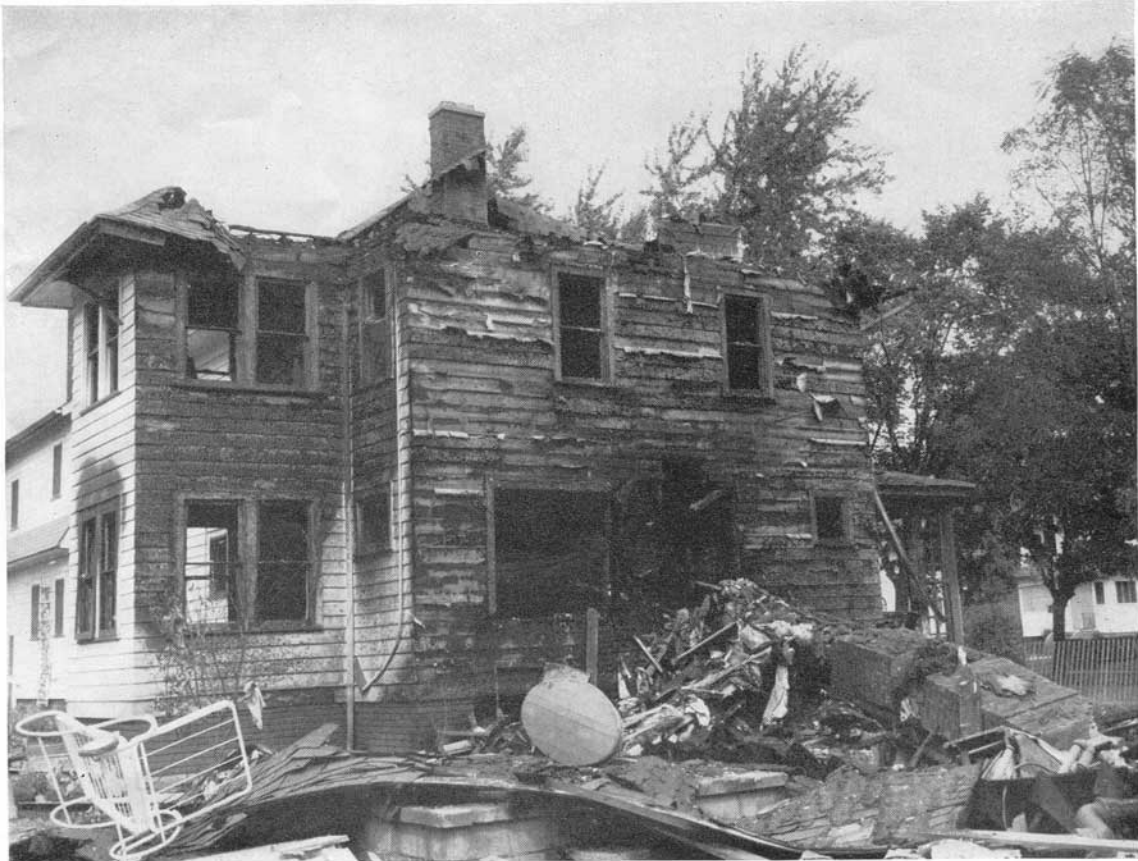
FIG. 18. Exposure fires were frequently severe as this photo taken at Fair Oaks Avenue shows.

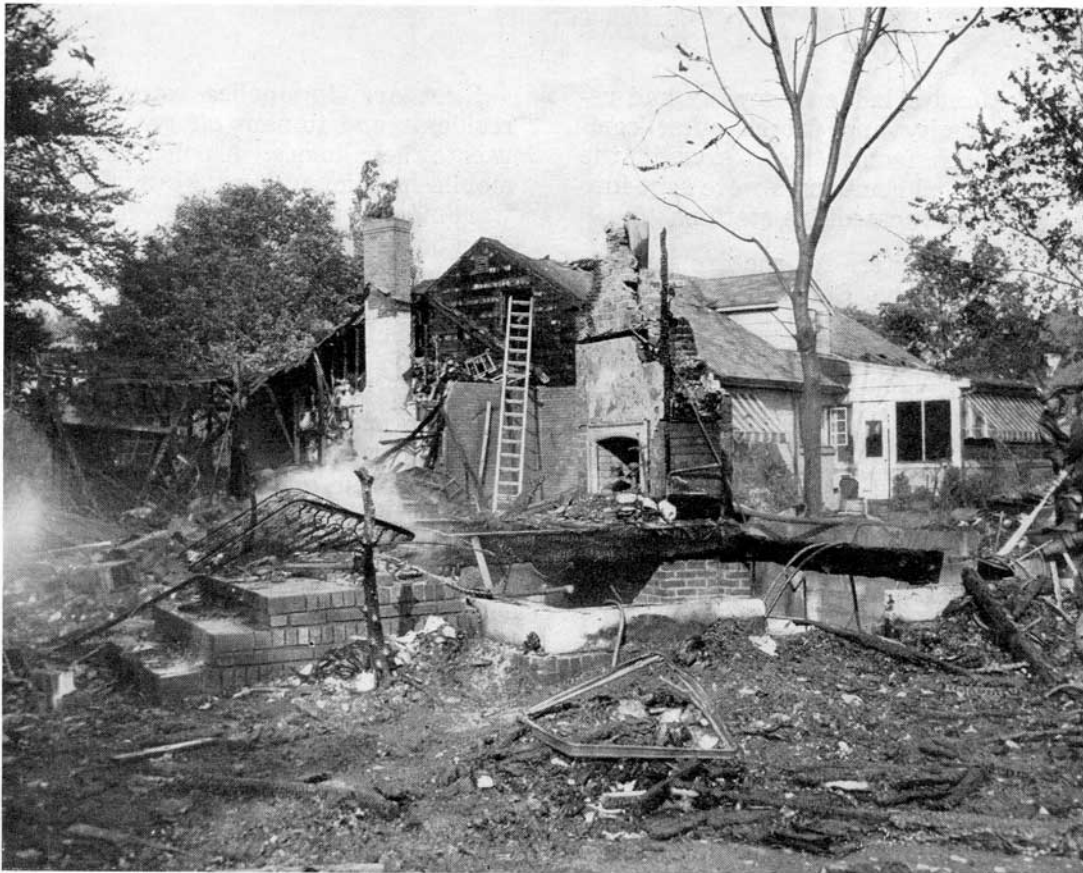
FIG. 19. Effects of explosion and fire at Oakdale and Mayflower Drives.

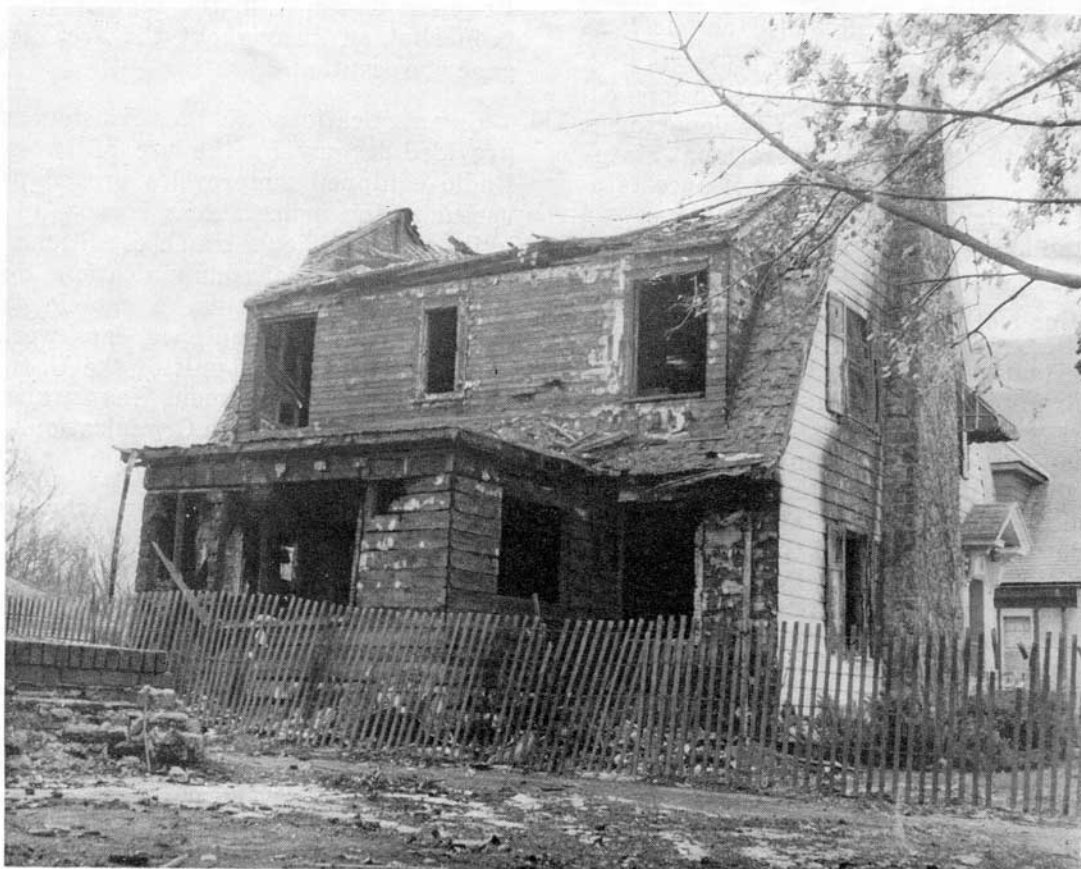
FIG. 20. Another example of fire exposure damage on Mayflower Drive.
