THE BRIGHTON GAS FIRE AND EXPLOSION CATASTROPHE

Town of Brighton (Monroe County), N. Y.

September 21, 1951

THE NATIONAL BOARD OF FIRE UNDERWRITERS

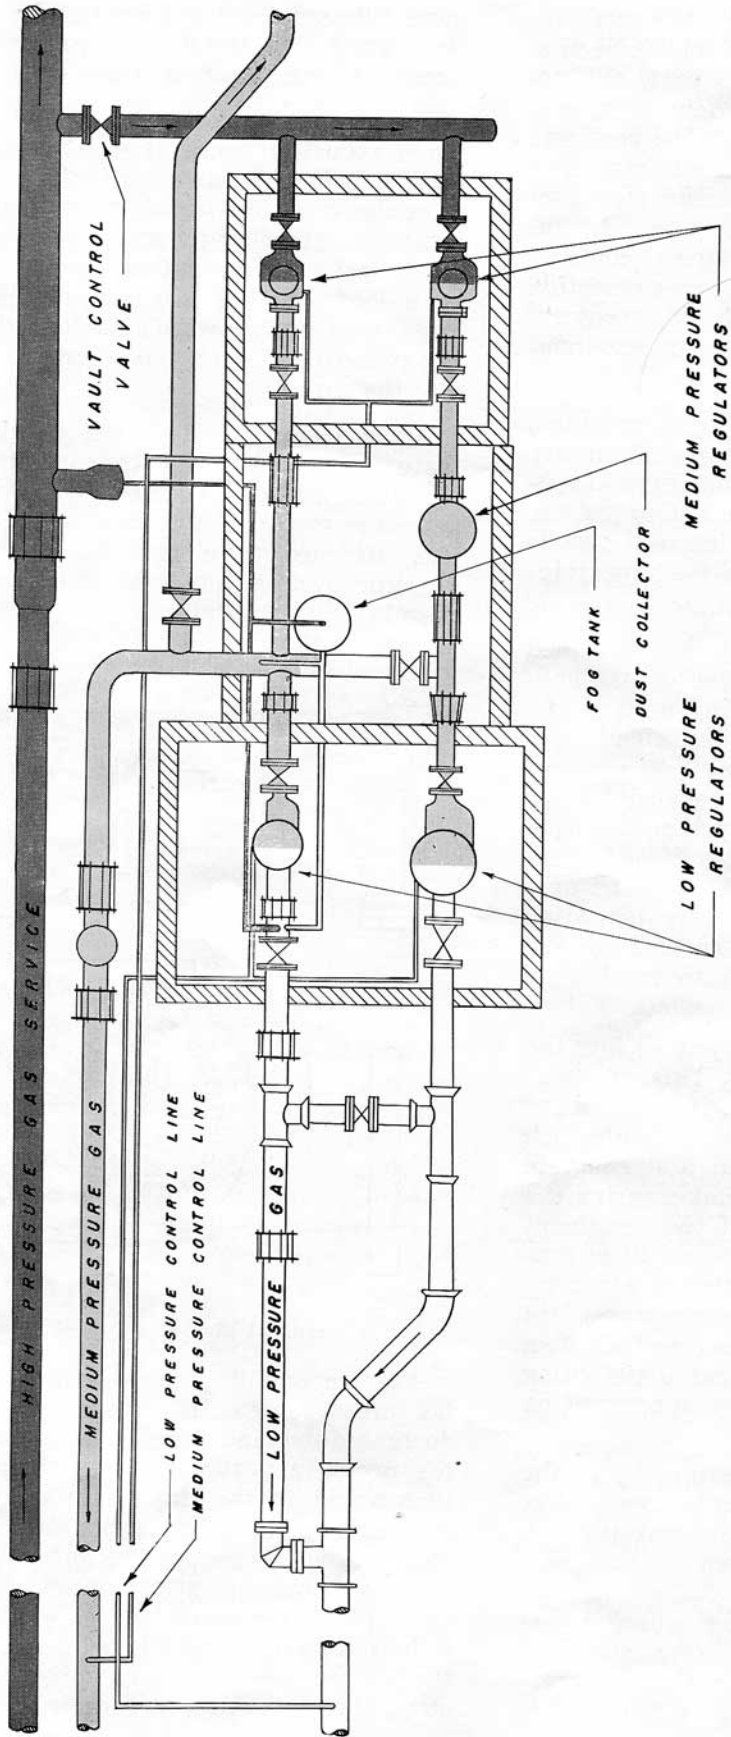
REGULATOR VAULT

At the time of the accident the piping and attendant equipment located in the regulator vault were arranged as follows. Two medium-pressure and two low-pressure regulators were set in pairs in a parallel position. Gas at 30 psi pressure was taken from the feeder main by an eight-inch pipe having a shut-off valve in a buried pit. This eight-inch pipe served as a short header from which two parallel six-inch lines ran into the first of three sections of the vault located under the sidewalk and adjacent to the street curbing. Either of the two lines could be used to supply the distribution system; customarily, one was used while the other was maintained as an alternate when maintenance work was in progress on the first.

The first section, approximately eight feet square and nearly seven feet high, housing the medium-pressure regulators, was constructed of eight-inch concrete blocks. To withstand possible loads and impact from passing trucks, the roof was purposely built of extra-heavy construction with 70 pound railroad rails placed flange to flange, covered with concrete to the street surface level. This section of the top was fitted with two large manholes having covers weighing 300 pounds each. These covers had no vents or other openings, except bar holes for lifting. The six-inch lines ran parallel to each other through this portion of the vault, each line connected to a pressure reducing regulator with necessary shut-off valves on each side of the unit. These first stage regulators reduced the gas pressure from 30 to a range of 15 to 5 psi, with the higher pressure setting for the peak loads of winter.

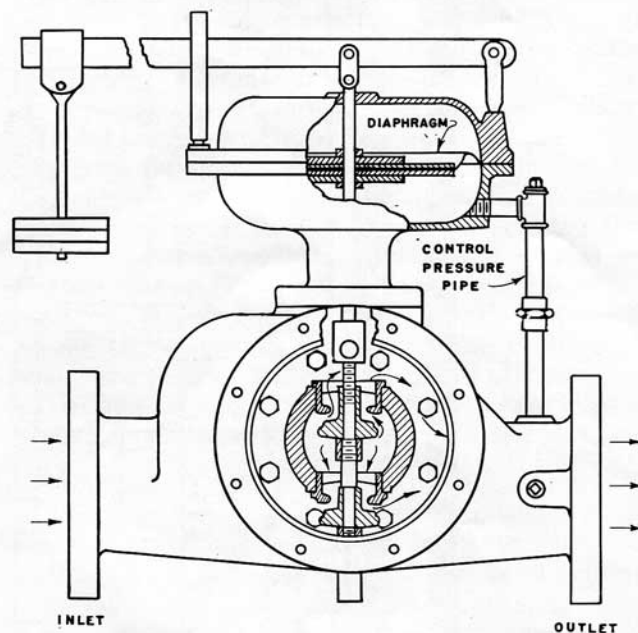
FIG. 3. Sectional View of a Typical Pressure Regulator.

Flow of gas through the regulator was adjusted by a throttling valve controlled by vertical motion of a shaft. (See Fig. 3) This valve shaft passed upward through the regulator casing and was attached to a flexible, oiled leather diaphragm over a gas-tight chamber; from this chamber a control pipe was connected to the outlet side of the regulator.

Any increase in pressure within the line on the low pressure or outlet side, as would result from decreased demand for gas, would therefore raise the pressure within the gas chamber. This in turn would lift the diaphragm and the valve stem connected to it. This upward movement would close the valve, reduce the flow of gas, and thus lower the pressure at the outlet of the regulator. Conversely, increased use of gas from the distribution system would reduce the pressure in the control line and gas chamber, lower the valve stem, open the valve, and increase the flow of gas.

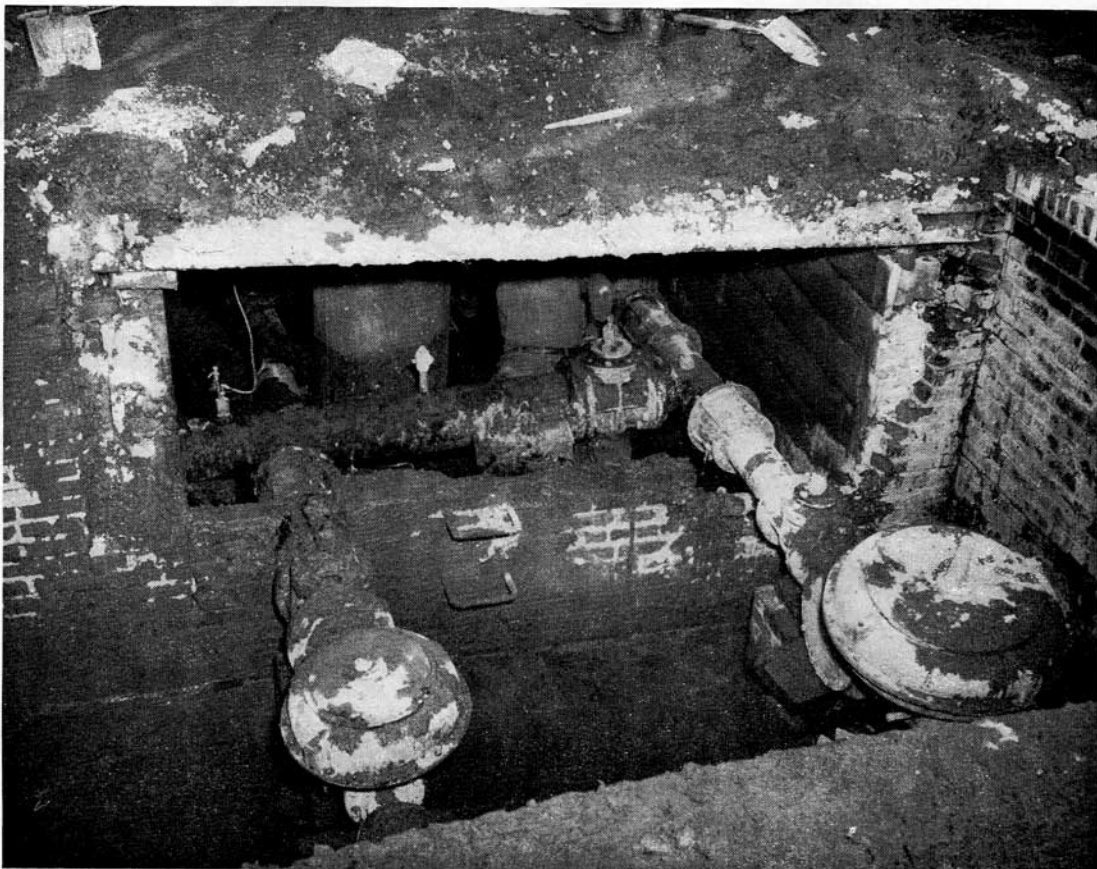
FIG. 7. Interior of regulator vault. Low-pressure regulators in foreground; fogging tank and cross-connection to medium-pressure system in adjacent vault.

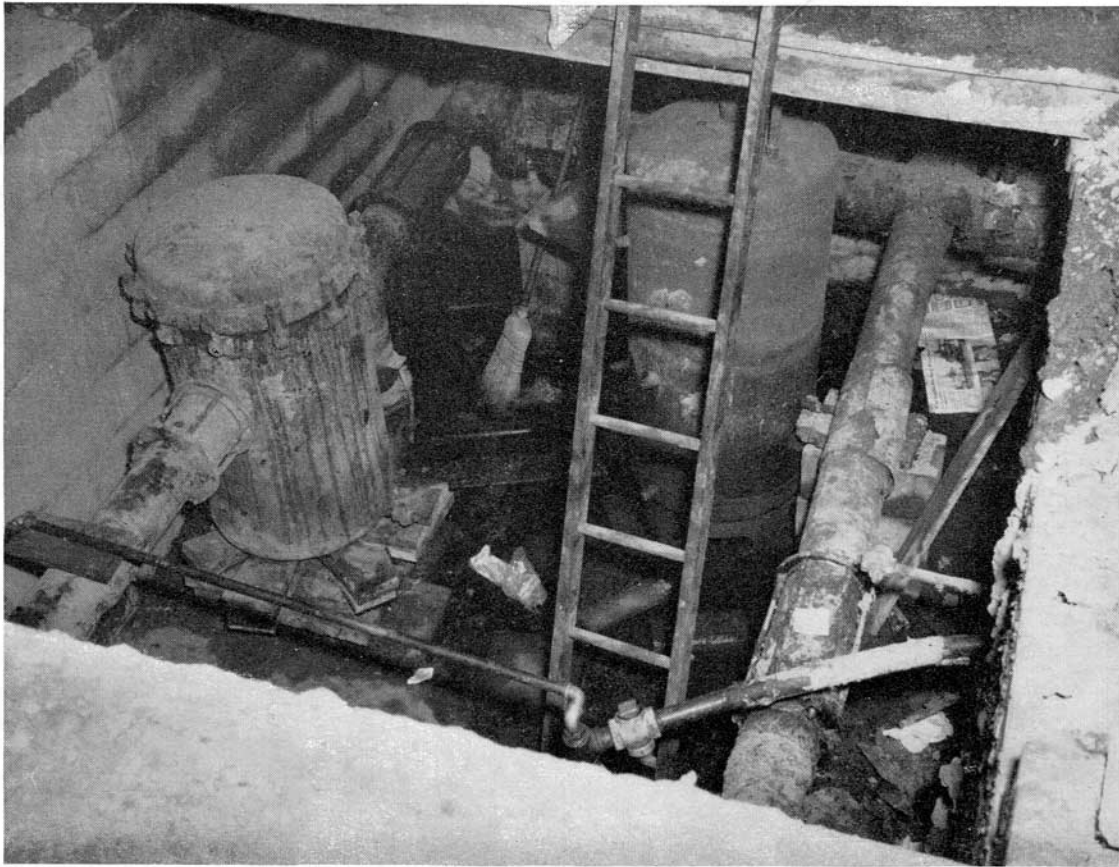
FIG. 8. Central chamber of regulator vault, looking toward low-pressure chamber, showing filter unit on left and fogging tank on right.

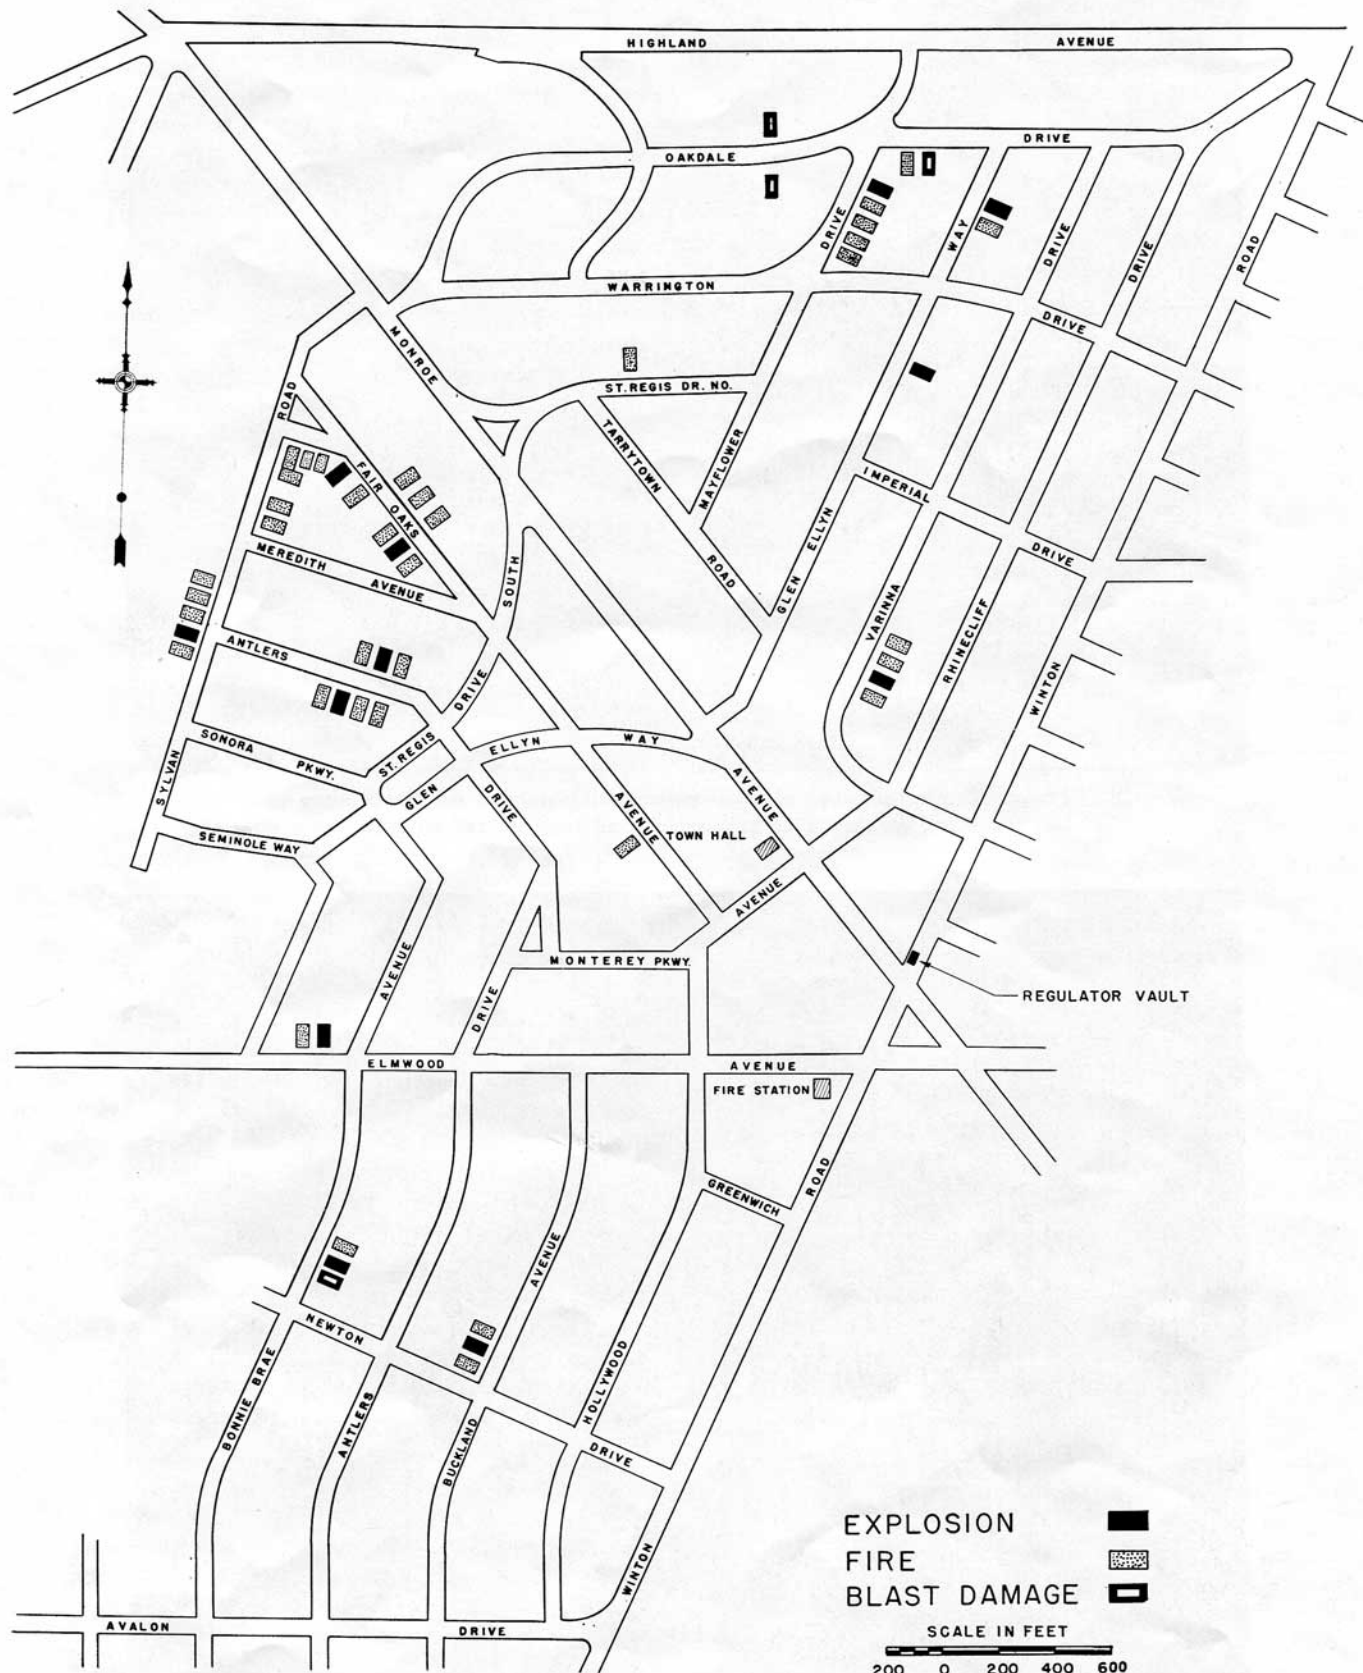
FIG. 10. Damage Map of Low-pressure District in Brighton.

throughout the area were shattered by explosions which in most cases completely demolished the buildings.
